# Lenham Archaeological Society

## Archaeological Watching Brief

### St. Mary's Church LENHAM

Extension on South side for toilets  
March- Aug. 2012

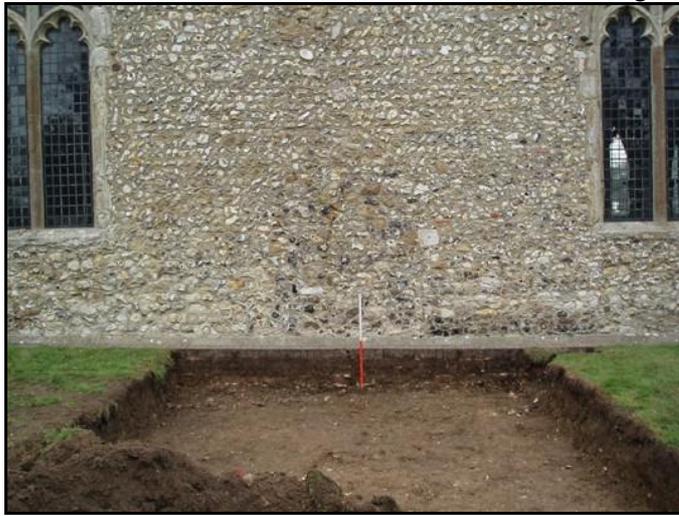
**1. South view of church wall and initial excavation 8.3.12 . Outline of the blocked in doorway can clearly be seen .**

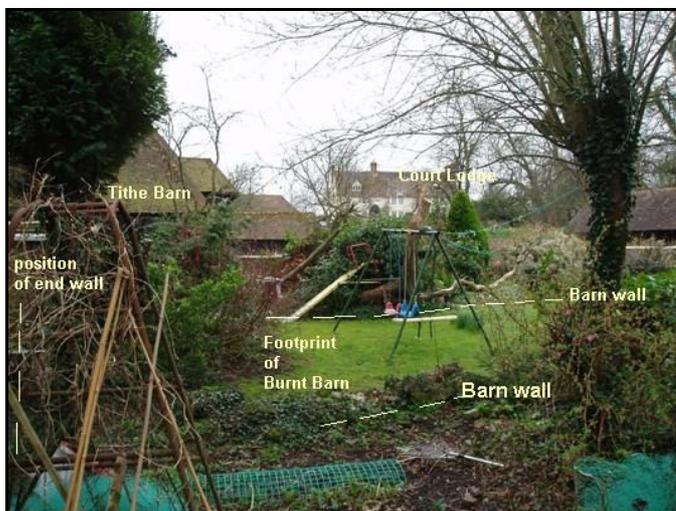
**2 . Photo looking SW.**

Apart from the church itself the nearest buildings of archaeological and/or listed status are the cottages in Church square and the footprint of a 14thC tithe barn that stood only 10m away until 1964 when it was burnt down .

The wall footings of this barn can still be seen in the garden of No 3 Church Square

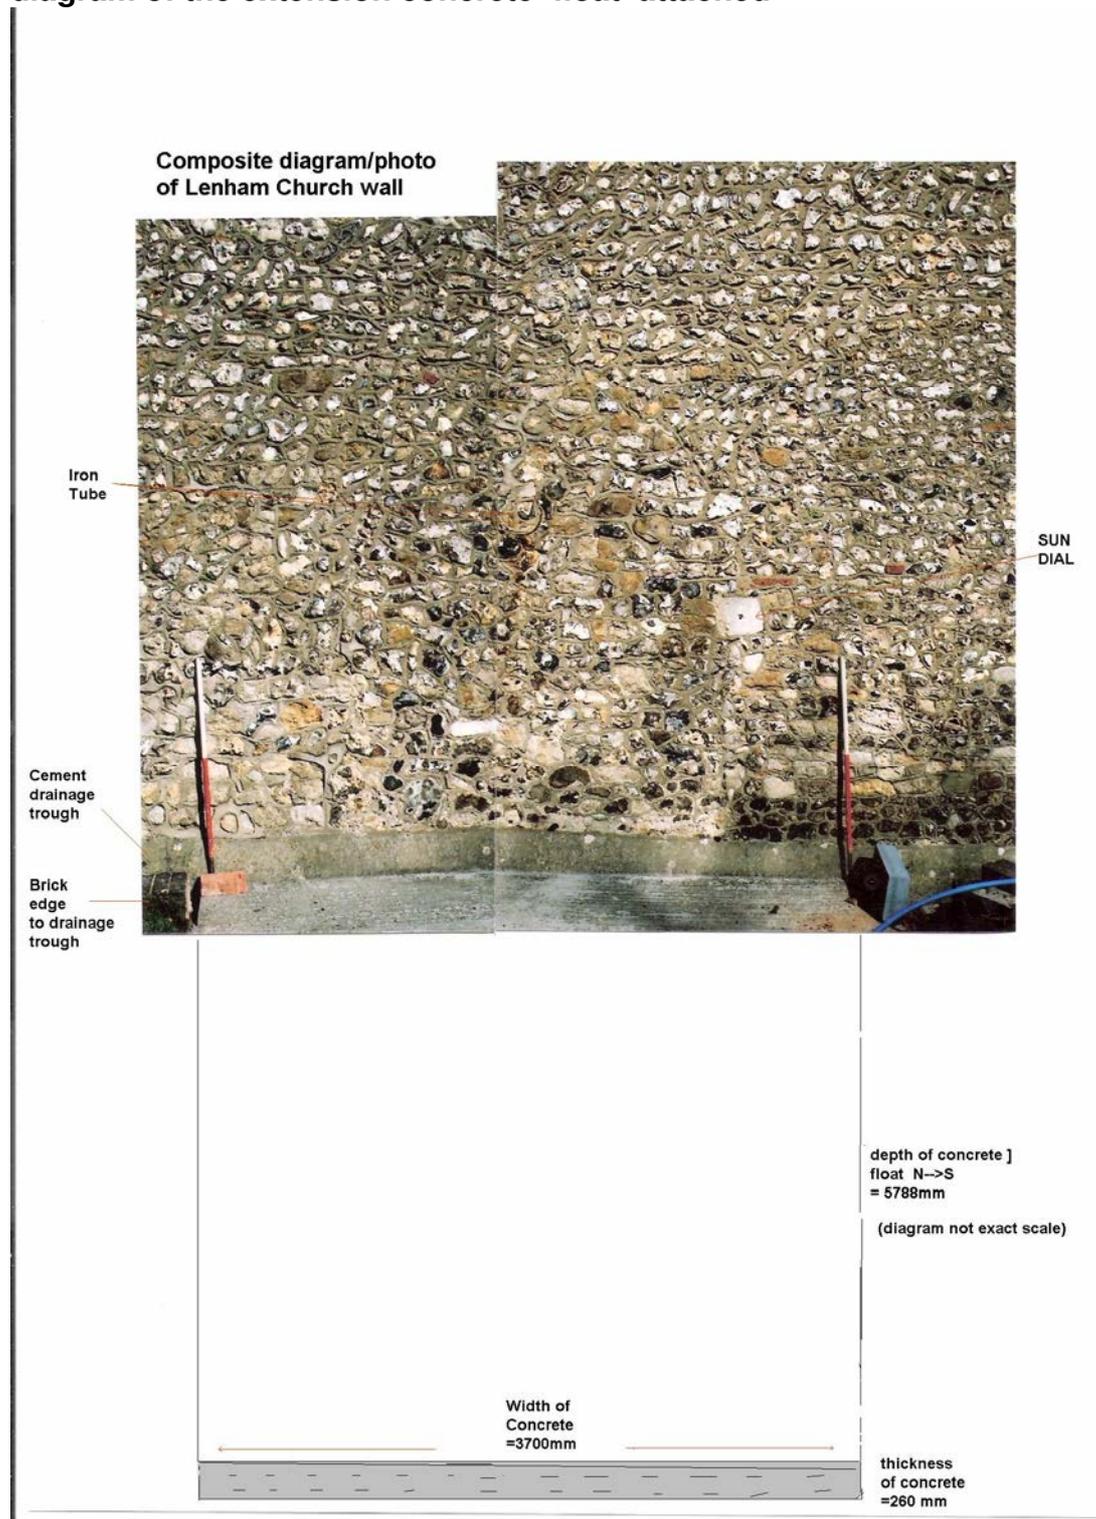
**EXCAVATION :-** Here is a composite picture of the church wall with diagram of the extension concrete float attached

Two grave stones were removed and set aside then the area for the foundation was excavated (see diagram above ) At no time did any of the trenches go deeper than the statutory 50cm . After the area had been excavated on 8.3. 2012 aggregate was tamped in and an iron reinforcing (two layers ) set in place for 26cm of concrete :-

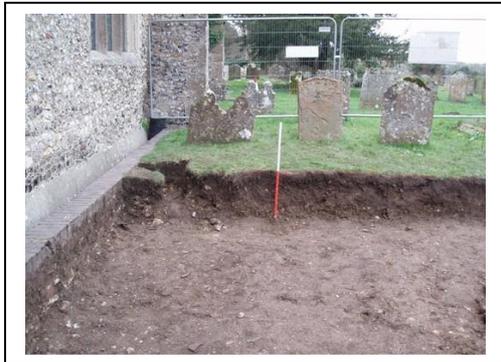
**5** Excavation looking east

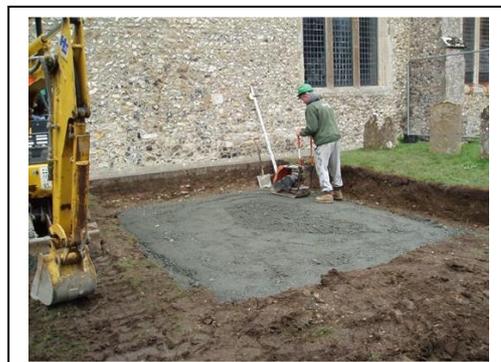
**6** Tamping the hardcore base

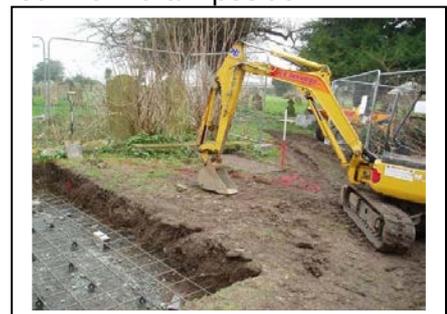
**8** Red line = drain position

Drain for the toilet was dug in the NE corner and the soak-away drain led south then bent SE . Two reasons for slight change in plan ... (1) was that a stone slab protruded from the adjacent vaulted tomb and (2) it was decided to keep the line sufficiently distant from the garden fence of the cottage so that large vehicles could negotiate the gap (if ever needed ) and not need to traverse the drain area . This drain area was eventually capped with concrete slabs .

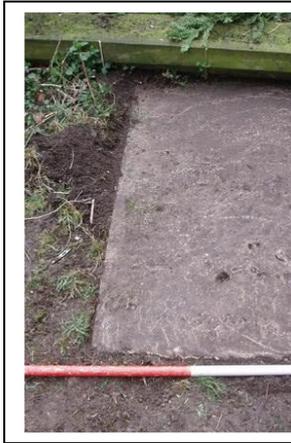
9 Stone slab

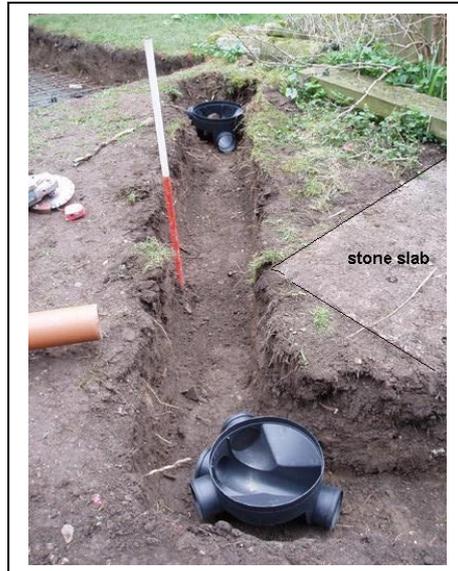
10 Drain from SE corner

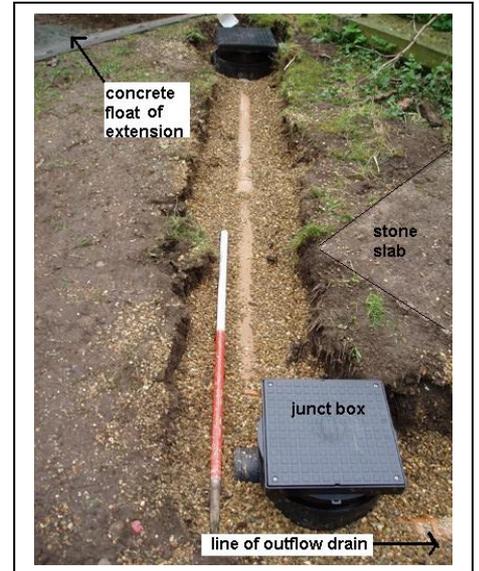
11 Drain with gravel

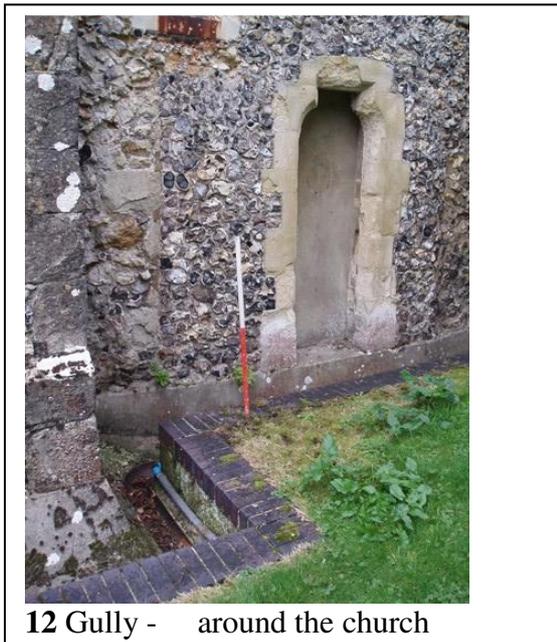
12 Gully - around the church

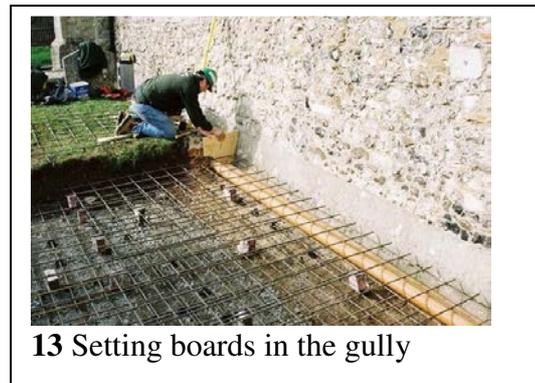
13 Setting boards in the gully

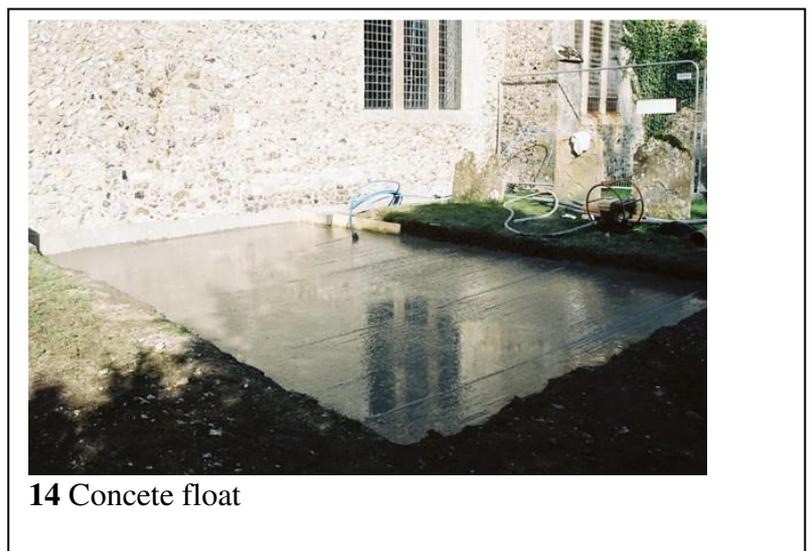
14 Concrete float

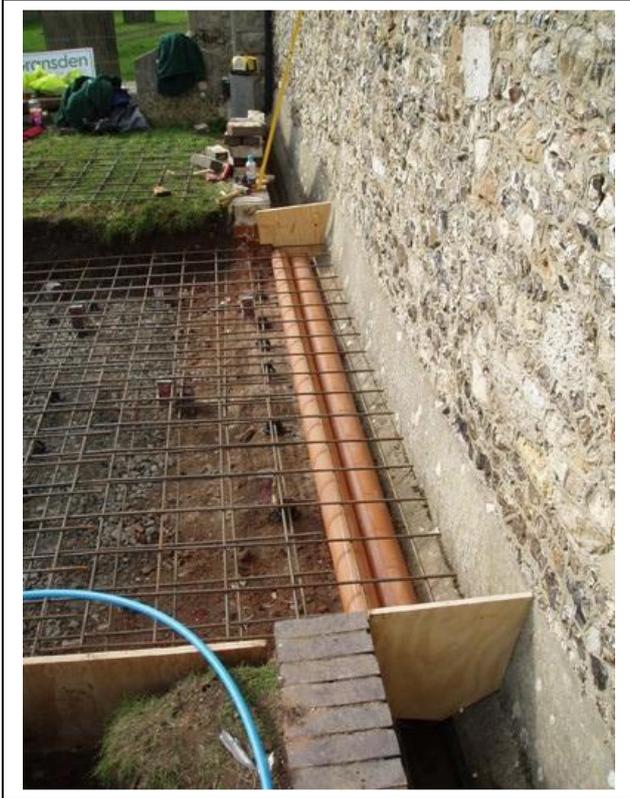
15 Drains along the church wall & showing their exit from the concrete float

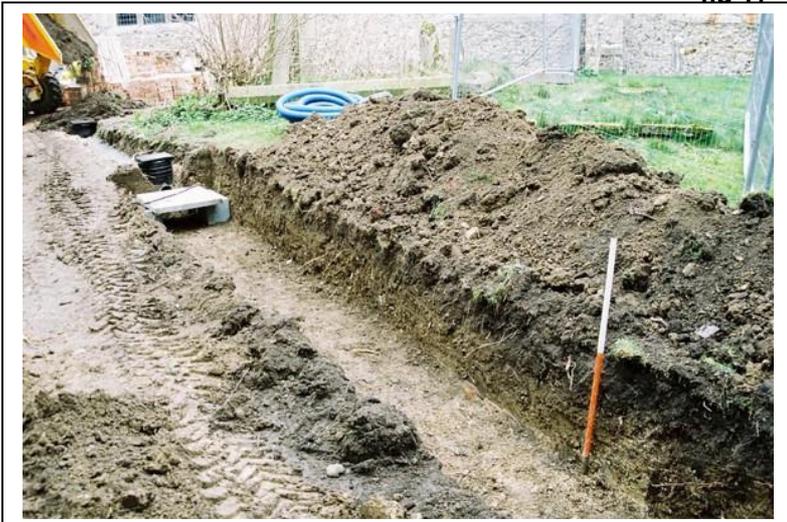
fig 17

Above is a photo of the sewer drain to the right looking down the length of it when the capping of concrete slabs was in place

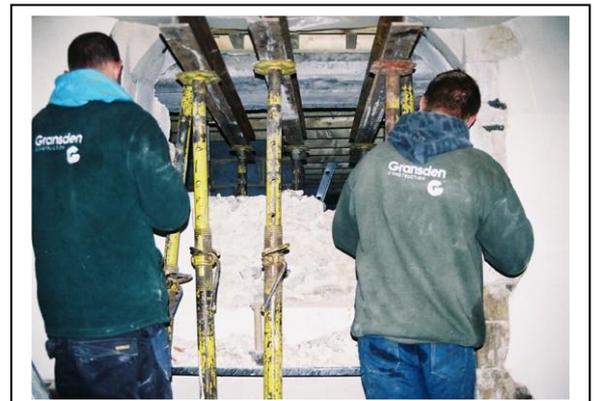
Set in this area of the church wall is an old scratch Sundial . The hole in the middle was to insert a stick and tell the time :-

26 a) Sadly it will be on an inside wall of the new extension as seen in knock through → 26 but preserved in a small niche. The structure of the church wall could now be seen in section ...see below in pic 27.

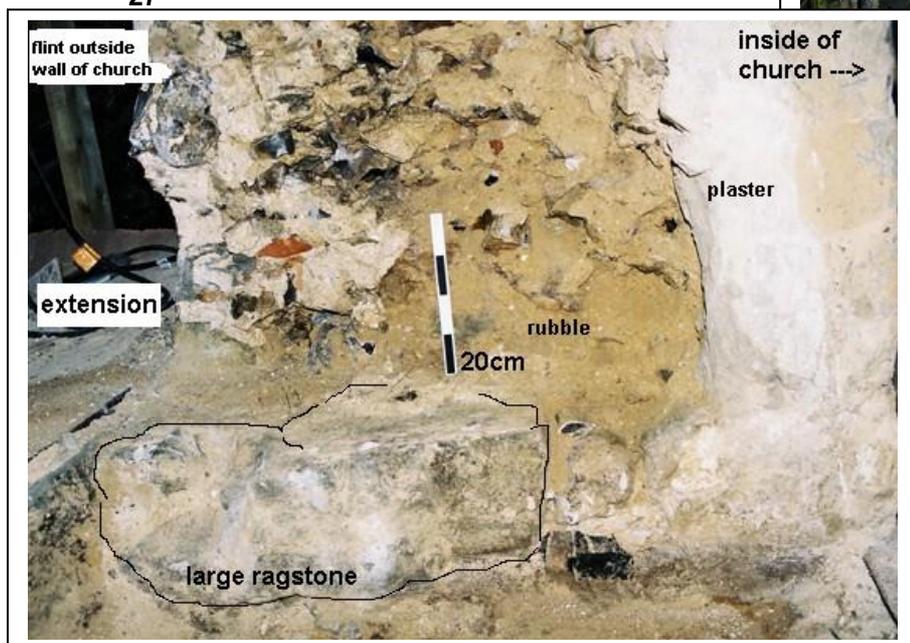
27

View of west side of broken church wall Just above floor level.

The pile of rubble to the left of the window has all come from the knocked through piece of church wall. Most was Kentish rag-stone and knapped flint . Much of the mortar had turned to dust and it was as though the church walls were now held up by the outside flint and inside plaster with mainly a dusty rubble in between !

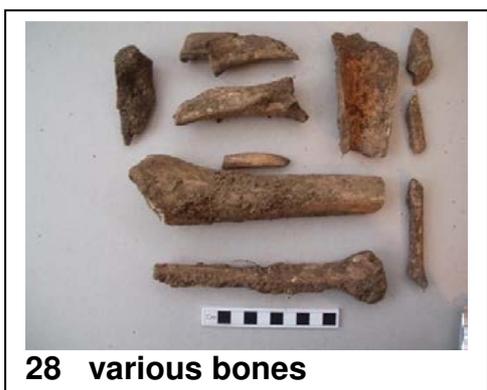
28 various bones

**Bones** came up in the excavation of the extension footings . They were very shallow and it would appear that they were dug up when the 18<sup>th</sup> C grave diggers were digging more recent graves . A clay pipe bowl dates between 1720-50 and would fit the date of the 1747 grave stone to the east.

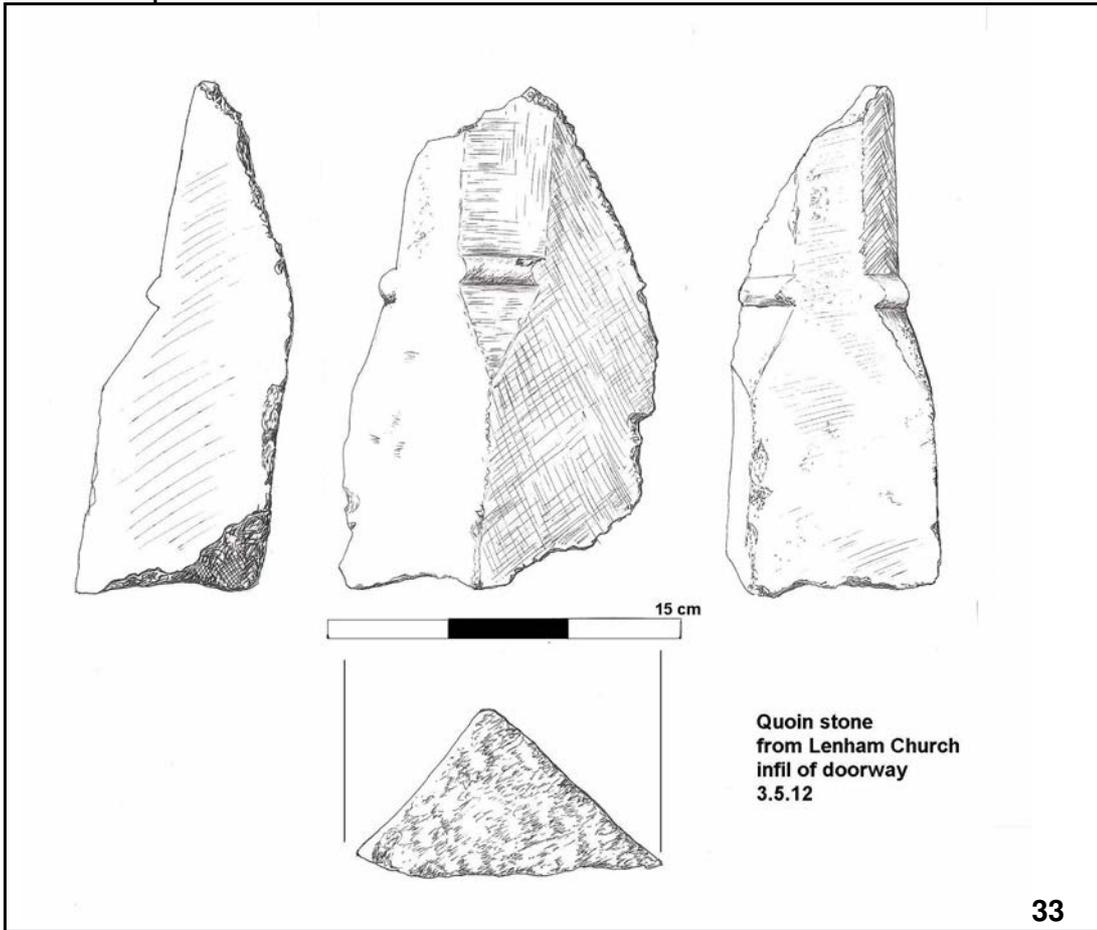
Carved piece of Caen Stone :-

When the flint and rubble came out of the arch area one of the first finds was this carved piece of Caen stone. It was quite pristine and unweathered and the typical creamy colour of Caen stone , obviously the base of a door pillar and comparable to some of 14<sup>th</sup>-15<sup>th</sup> Century in Boughton Monchelsea church . It matched nothing we have on doorways in Lenham . Where the rest of the door arch is we have no idea. It would fit with an account of an early "Lord of the Manor" who required a door on the south side closer to his house ! Perhaps his house was the footings we found with resistivity near the present barn ?.....more scope for research!

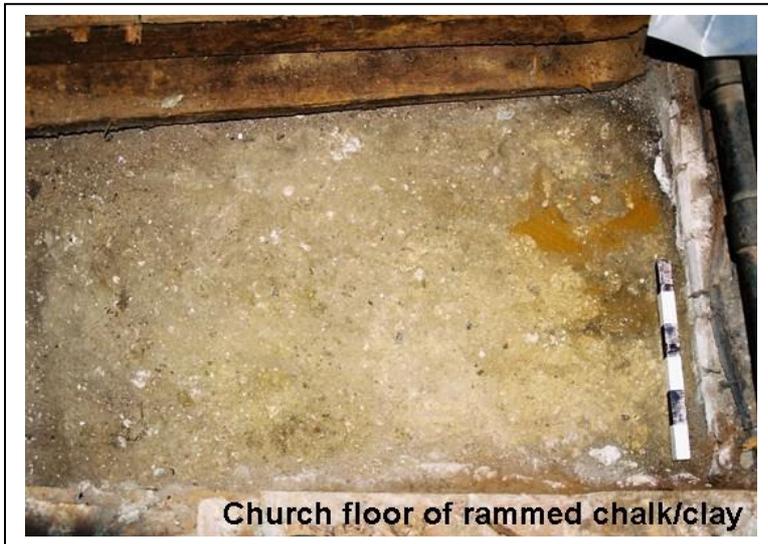
40

Additionally, the church floor under the floor boards was interesting it seems to be a rammed chalk and clay surface. (see picture 40)

Church floor of rammed chalk/clay

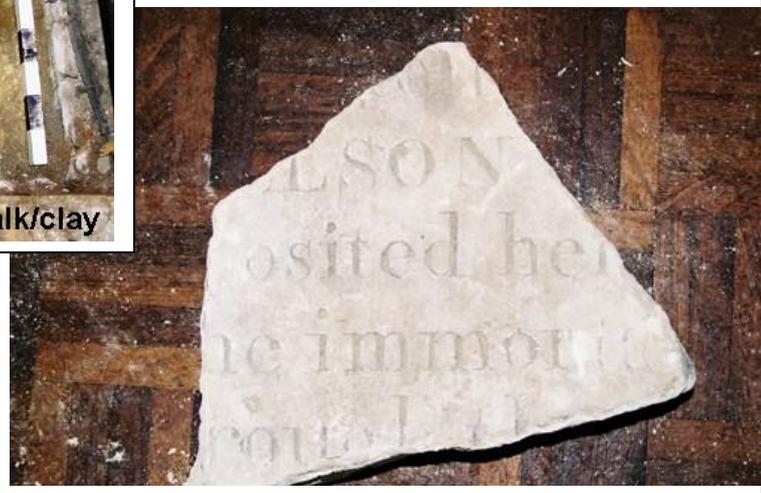
41

Further proof of the infill date could be when a certain Mr Wilson was buried , as a section of carved tomb stone was also found in the rubble of the doorway infill.

The broken tomb stone of a certain person called Wilson  
(or is it Coulson or Fulson ?)
