Lenham Archaeological Society

The DIG at LENHAM COURT on the front lawn

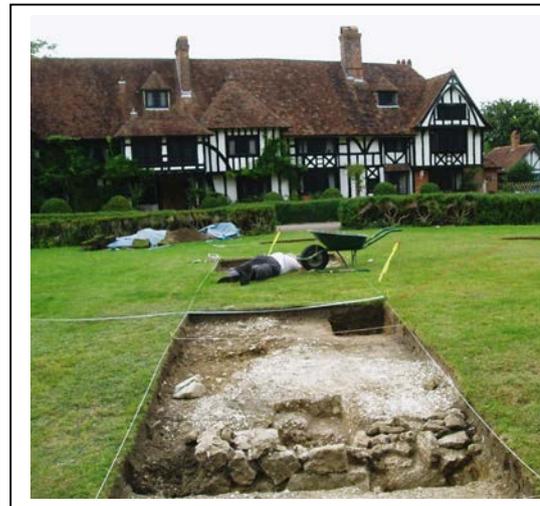
Lenham Court dig 2010, on the front lawn Northern (oldest part of the house is visible)

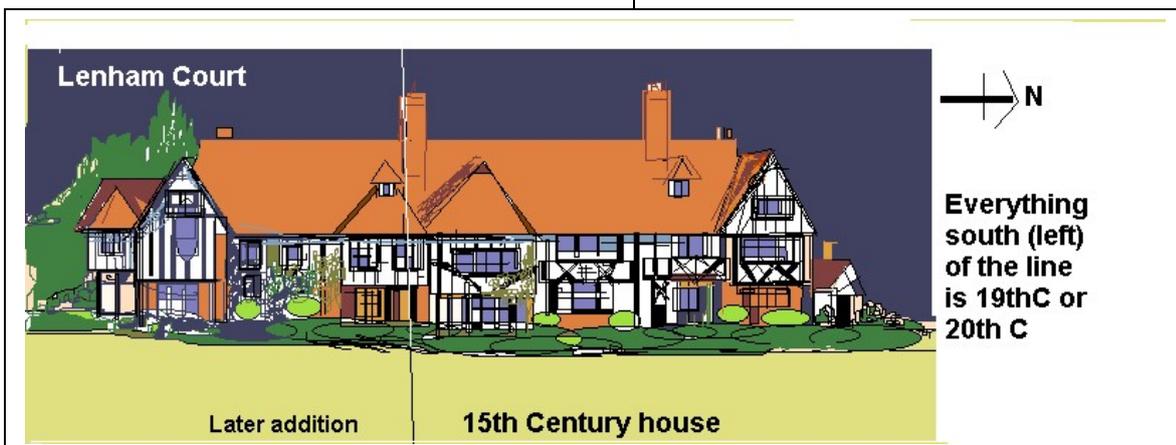
Modern map with 1867 overlay

On these overlaid maps (modern in colour and a 1867 in black) the various extensions and demolished buildings can be worked out. The following resistivity plot , done in Sept 2009 shows areas of dense material

When all the different OS maps of Lenham Court are overlaid there appears a jumble of buildings once standing to the west of the house on the present lawn. All are now gone. The house itself has a very different footprint from the 1841 plan . Buildings to the south have been demolished and the house extended in a slightly different line . Everything south of the present front door can be safely interpreted as 'modern'. As this extension has been so well done it is difficult to discern this dramatic change . Remnants of a wall was visible running at an E→W angle across the lawn as a parch mark in the summer of 2009.

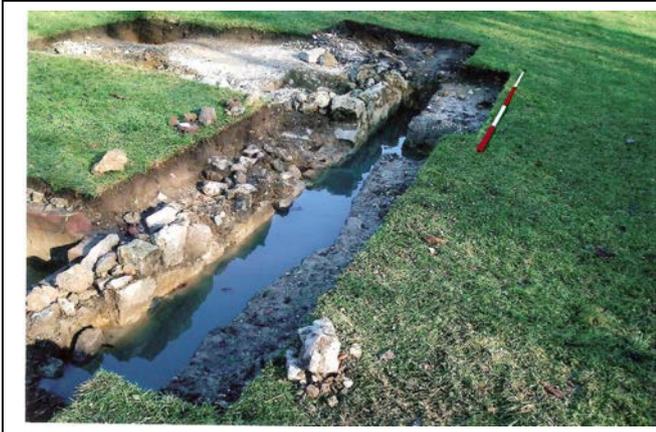
The first trench opened in Aug 2010 was one across the area of high resist area at the pond end of it . This eastern edge proved to be a substantial ragstone wall with large blocks set in deep clay . There did not appear to be any mortar on the lower levels. It was surmised that the pond could have extended at one time right up to this wall like a moa. Later with heavy rain in late Sept this theory was made even more plausible :-

Moat that appeared after we dug !
Looking North along the trench.

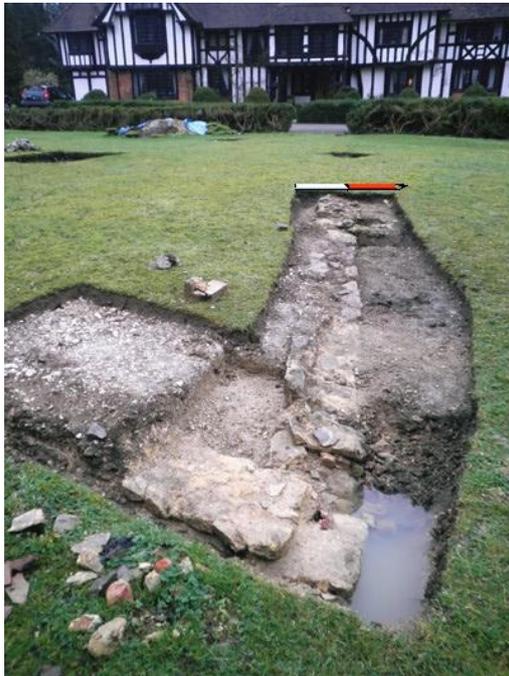
As stated before trenches were opened across the parch mark the ran east from the house towards the pond . This proved to be another 60cm wide ragstone wall that joined at a 60 degree angle with the first wall.

Northern end of the rag-stone wall
Showing the 60 degree angle as it travelled west towards the house

This strange angle confused at first until it was noted that the angle of the building on the 1867 map fits that configuration. At the southern 'end ' of the first wall brick buildings had been constructed using it as a foundation .It is uncertain if the one of these brick structures represented the building on the 19thC map. It looked more like a sunken greenhouse and west of it was this strange 19th-20C structure:-

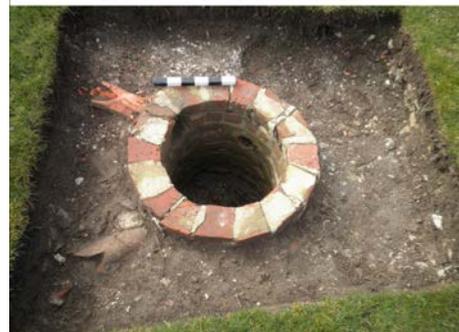
Measure =30cm . **Brick structure =60cm**
"drains sloping down into it and a lower one draining out

The most likely explanation for this is that it is a drainage sump for water off the roof of the greenhouse .

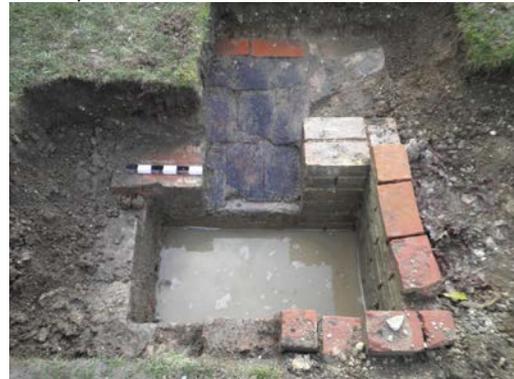
Another feature that was discovered and fits with the small square to the SE of the 19thC building on the map is an outhouse:-

Old fashioned early 19thC latrine

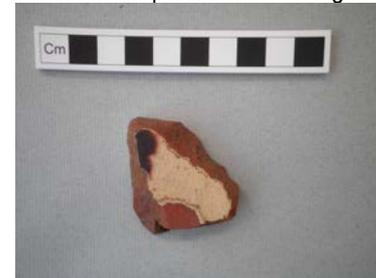
It was difficult to find many datable small finds at all . The only piece of distinctive pottery (bar flower pot was this small piece of 17th-18 C glazed slip ware :-

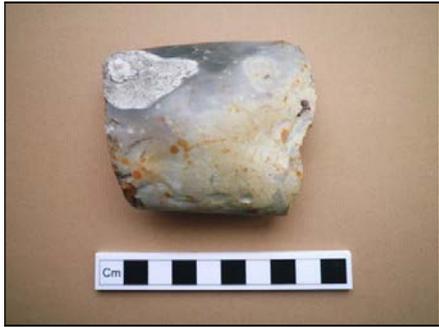
Also,under the stone wall wedged in the clay beneath it was a broken piece of a Neolithic polished flint axe. Proof that centuries ago it was once discarded in a pond ?

Broken Neolithic axe
